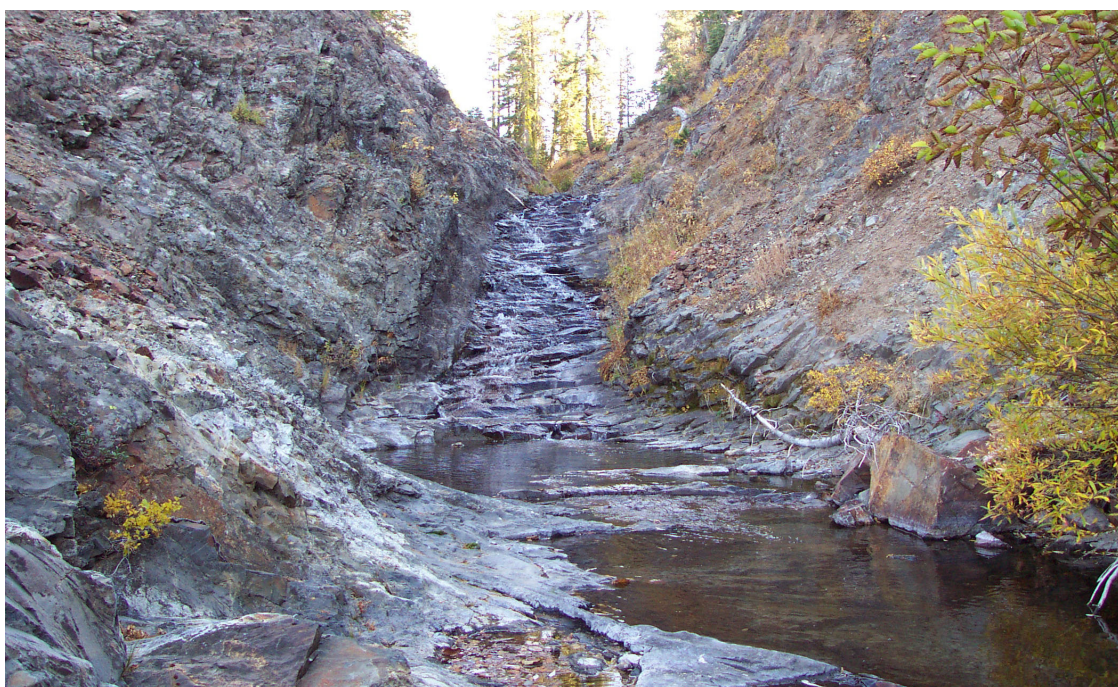
**Figure 4-22. Bedrock channel with a “low” fine sediment rating typical of the canyon reach of Blackwood Creek.**

The eastern fork reach, upstream from its confluence with the Middle Fork (Hotspots 17 to 21, Table 4-8), transitions from a boulder/cobble bed to a bedrock controlled channel. Banks are steep with essentially no sediment available for erosion (Figure 4-22). However, near the Barker Pass Road crossing, the channel banks are covered by a layer of colluvial material with a high silt/clay content.
